Service Bulletin

Bulletin No.: 17-NA-276

Subject: Loss of Phone Pairing or Favorites, Last Setting of Volume, Station, App, and Audio Settings Change When Vehicle Shuts Down in Demo Mode

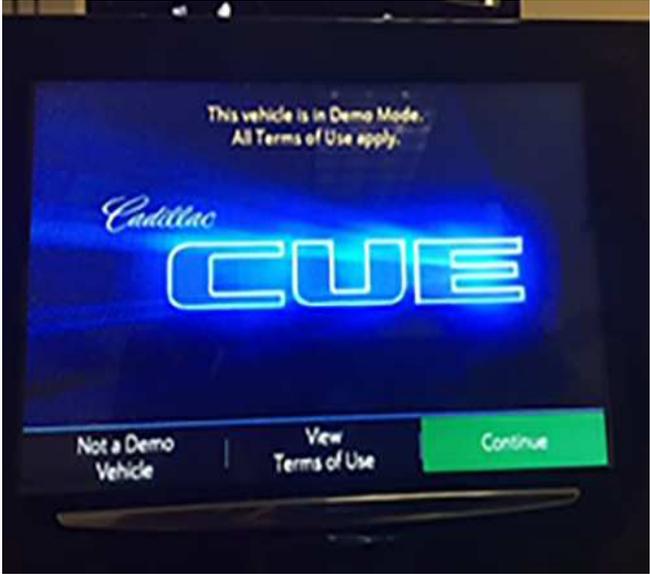
<p>Condition</p>	<p>Some customers/technicians may comment that when the vehicle is in Demo Mode (unsold vehicle), the phone would stay paired for the key cycle and then would lose pairing to the radio after the vehicle shuts down and started after 10 minutes, unable to log in or create a User Profile. Additional operational characteristics of Demo Mode include no retention of the following:</p> <ul style="list-style-type: none"> • Stored Favorites • Last station tuned • Bluetooth synced device(s) • Volume level (too soft or too loud) • Last app or screen view • Audio/equalizer settings <p>Loss of functionality on the above items may be due to the design intent of the vehicle while in Demo Mode.</p>
<p>Cause</p>	<p>This may be due to the design intent of the vehicle in Demo Mode.</p>

<p style="text-align: right;">5134106</p> <p>Cadillac shown, Buick, Chevrolet and GMC similar.</p>
<p>Correction</p>	<p>Note: If a device was originally paired while in Demo Mode, a similar condition could occur that randomly continues to drop Bluetooth pairing even after exiting Demo Mode. If the vehicle is not in Demo Mode, but it is believed that the device was originally paired while in Demo Mode, then delete the device from the radio, delete the radio from the device, and pair the device again.</p> <p>No correction is needed for this condition. This is the normal operating characteristic of the Demo Mode of the vehicle. Once the vehicle is sold, select the option labeled "Not a Demo Vehicle" to exit Demo Mode.</p> <p>This information is also now available in SI description and operation documents. Refer to <i>Radio/Audio System Description and Operation</i> in SI.</p>
